U.S. CHEMICAL SAFETY AND HAZARD INVESTIGATION BOARD

INVESTIGATION REPORT

DUST EXPLOSION

**WEST PHARMACEUTICAL
SERVICES, INC.**

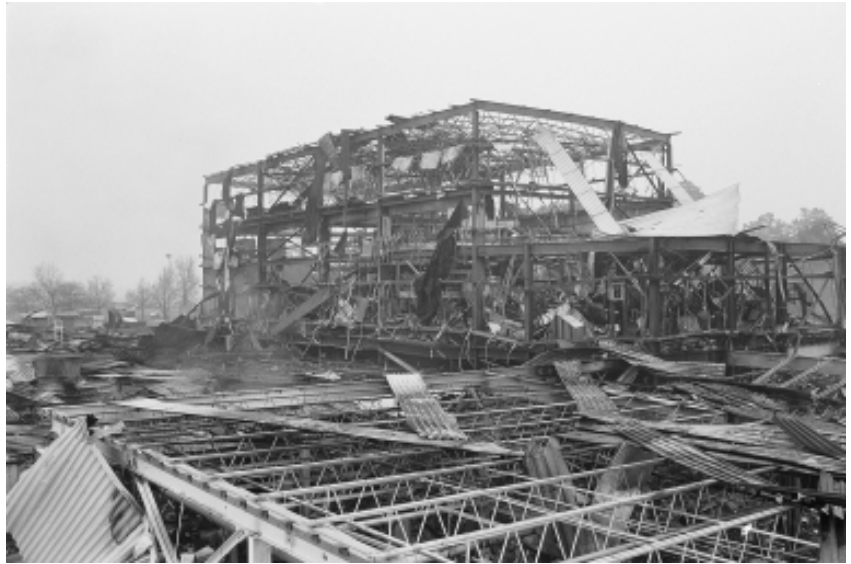
The explosion and ensuing fire heavily damaged the compounding section of the Kinston facility. Photographs below and in the remaining sections of this report show the extent of damage. All exterior sheathing on the compounding structure was destroyed. Masonry block walls were knocked down, the warehouse collapsed, and the building was rendered mostly unusable (Figures 6 and 7).

Figure 6. Roof of facility, with two-story compounding section in background.

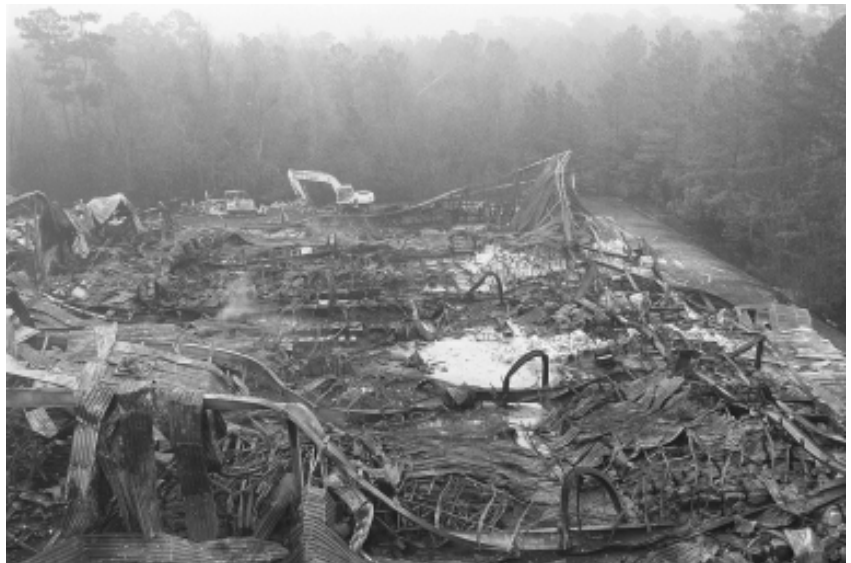
Figure 7. Remains of ACS warehouse viewed from compounding area.

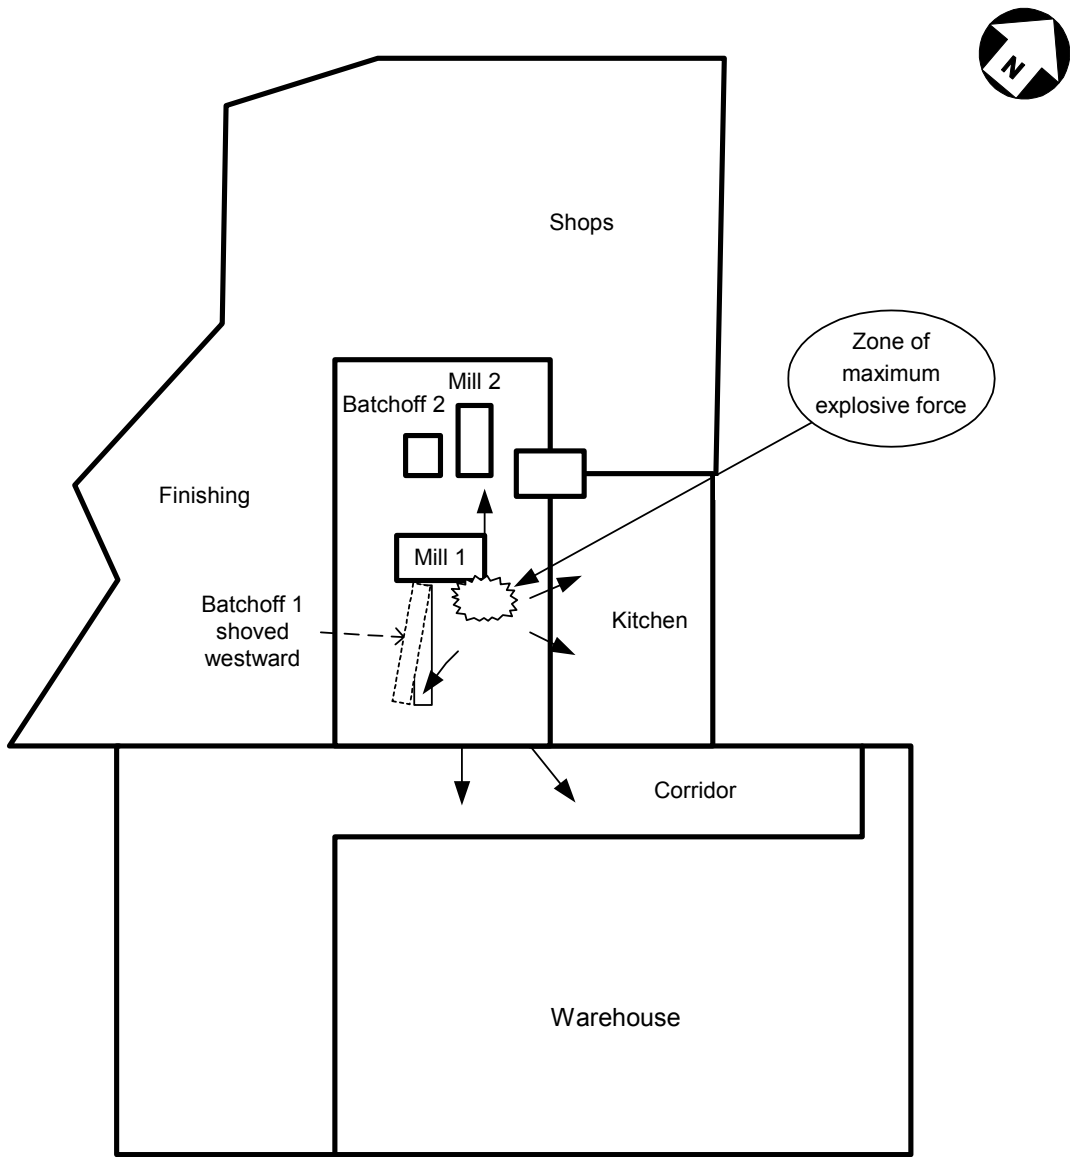
mill #1 (Figure 9). Force vectors derived from observed damage to the building and surrounding equipment indicate that the largest pressure developed in the compounding section and emanated spherically outward (Figure 10). Appendix B describes the damage patterns CSB used to estimate the directions and magnitude of explosive force.

Nearly all of the [ceiling] tiles appeared to be burnt and splattered on the top.

- Nearly all of the tiles appeared to be burnt and splattered on the top—but not on the bottom, which had faced the room below.
- Some of the fluorescent light fixture pans recovered from the mill #1 area were flattened from above, as if they had been forcefully driven downward to the concrete floor.

These two items of evidence further support the theory that the explosion occurred within the confined space above the suspended ceiling.

Figure 9. Estimated zone of maximum explosive force.

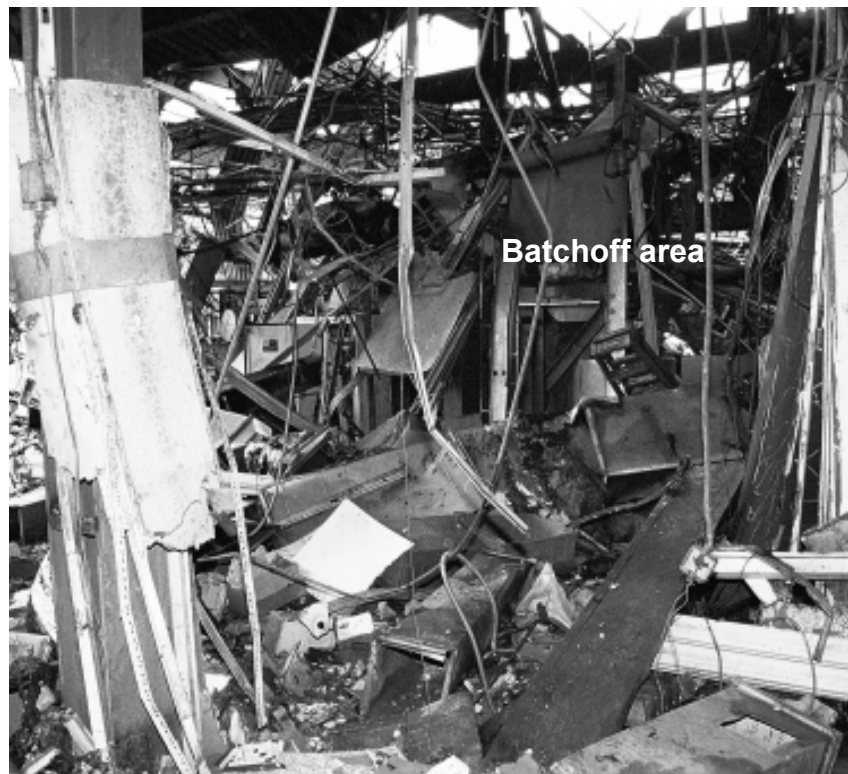
The extent of damage to the Kinston facility made it extremely difficult to definitively determine the event that dispersed the dust or what ignited it (Figure 11). Investigators focused on the most pertinent hazard—the accumulation of combustible dust—and considered the initiating event as a matter of secondary

- Overheating of a batch of rubber and subsequent ignition of the vapors produced by thermal decomposition.
- Ignition of the dust layer by an overheated electrical ballast or light fixture.
- Ignition of the dust layer by an electrical spark from an unidentified electrical fault.
- Unsettling of dust in a cooling air duct for an electric motor and subsequent ignition of the dust by the motor.

Figure 11. Extensive damage and debris near mill and batchoff machine #1.

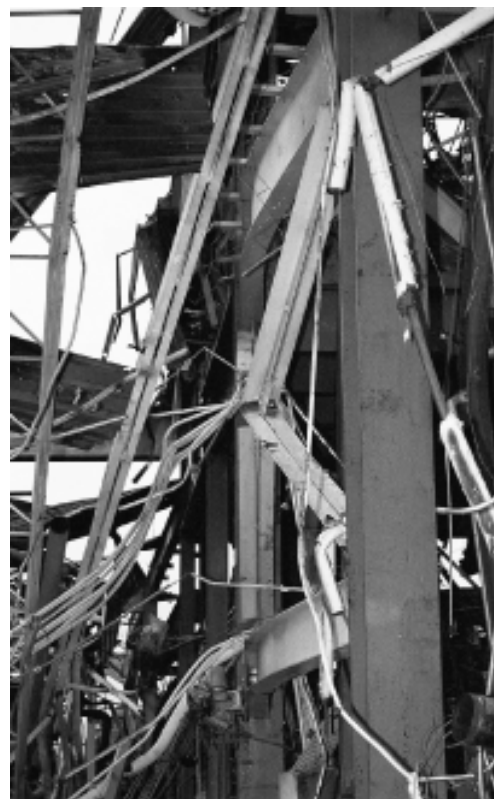
In examining the damage to structural steel and masonry block walls, CSB determined that the most severe forces—which emanated with a blast pattern of 360°—were on the first level of the plant in the area southeast of mill #1.

Figure B-1. Beam and cross bracing deflected southeastward toward warehouse.
